Technical Bulletin *élan*

SCCA-TB-001

Subject: Steering Spline Revision

Date: 04-12-05

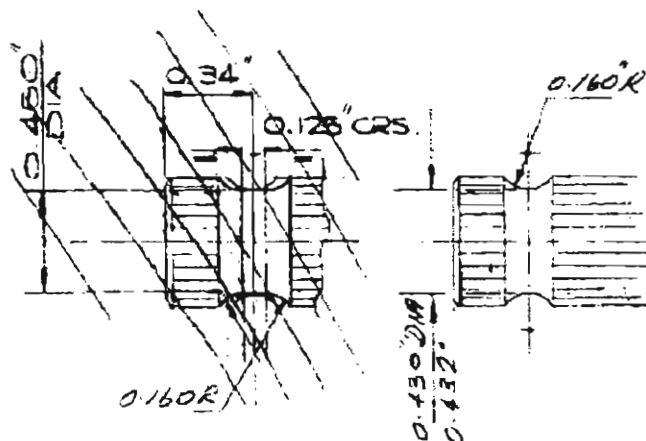
TYPICAL GROOVE DETAIL
SCALE 2:1.

In the interest of developing safety and reliability for the FSCCA/SPSCCA, an updated spline detail has been incorporated into the steering column. The width of the pinch-bolt clearance groove in each of the splines has been narrowed to allow a larger area of engagement between the joints and the splined shafts. This alteration will be applied to both the lower spline of the steering column and the upper spline of the lower column section, both where attached to U-joints. All future parts, supplied with the next car (from date of this bulletin) and onward, will benefit from this update. Attached are the applicable drawings for these parts.

Please note that both the previous and current generation of steering splines should benefit from the proper wear-in procedure. This consists of suitable tightening at the time of assembly and check prior to "shakedown." After 2-3 laps it should be checked/re-torqued and after approximately 20 laps it should be checked again. If this method is followed properly, in conjunction with regular maintenance, this joint should never loosen during operation.
