Technical Bulletin

SCCA-TB-002

FSCCA - SRSCCA

Subject: **Rear Wing Mount Revision**

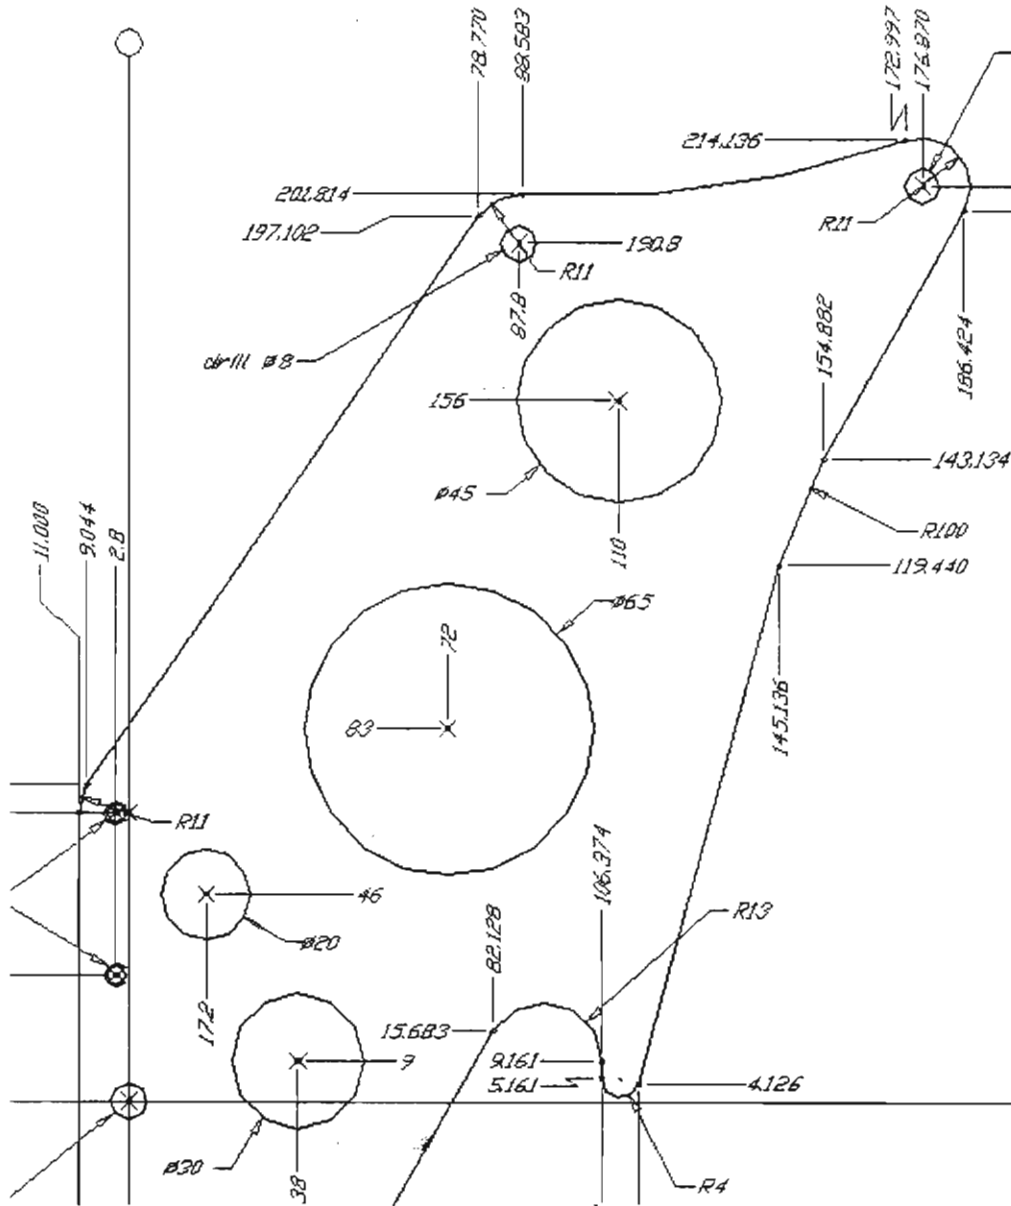
There have been rear collisions in the FSCCA series resulting in the rear transmission covers breaking. This is determined to be a result of the impact transferred through the rear wing mounting pylons. In order to combat this failure, because of the cost associated with replacing the rear transmission cover, the rear wing pylons will be weakened by way of holes machined near its base. These holes will promote buckling of the rear pylons. As no two track incidents are identical, it is difficult to ensure any type of consistent breakage, however, the reduced strength of the pylon will ensure that it absorbs rather than transmits a larger portion of any impact it experiences.

The updated portion of the drawing for this part is attached and may be used to alter any existing parts. Any parts in Van Diemen stocks will be updated and all cars from the date of this bulletin onward will benefit from this updated geometry.
